STRUCTURAL INTEGRITY,

ACCELERATED CORROSION

FLOW CAPACITY TESTS

VALVE, CHECK, ONE-INCH, AIRBORNE, FUEL

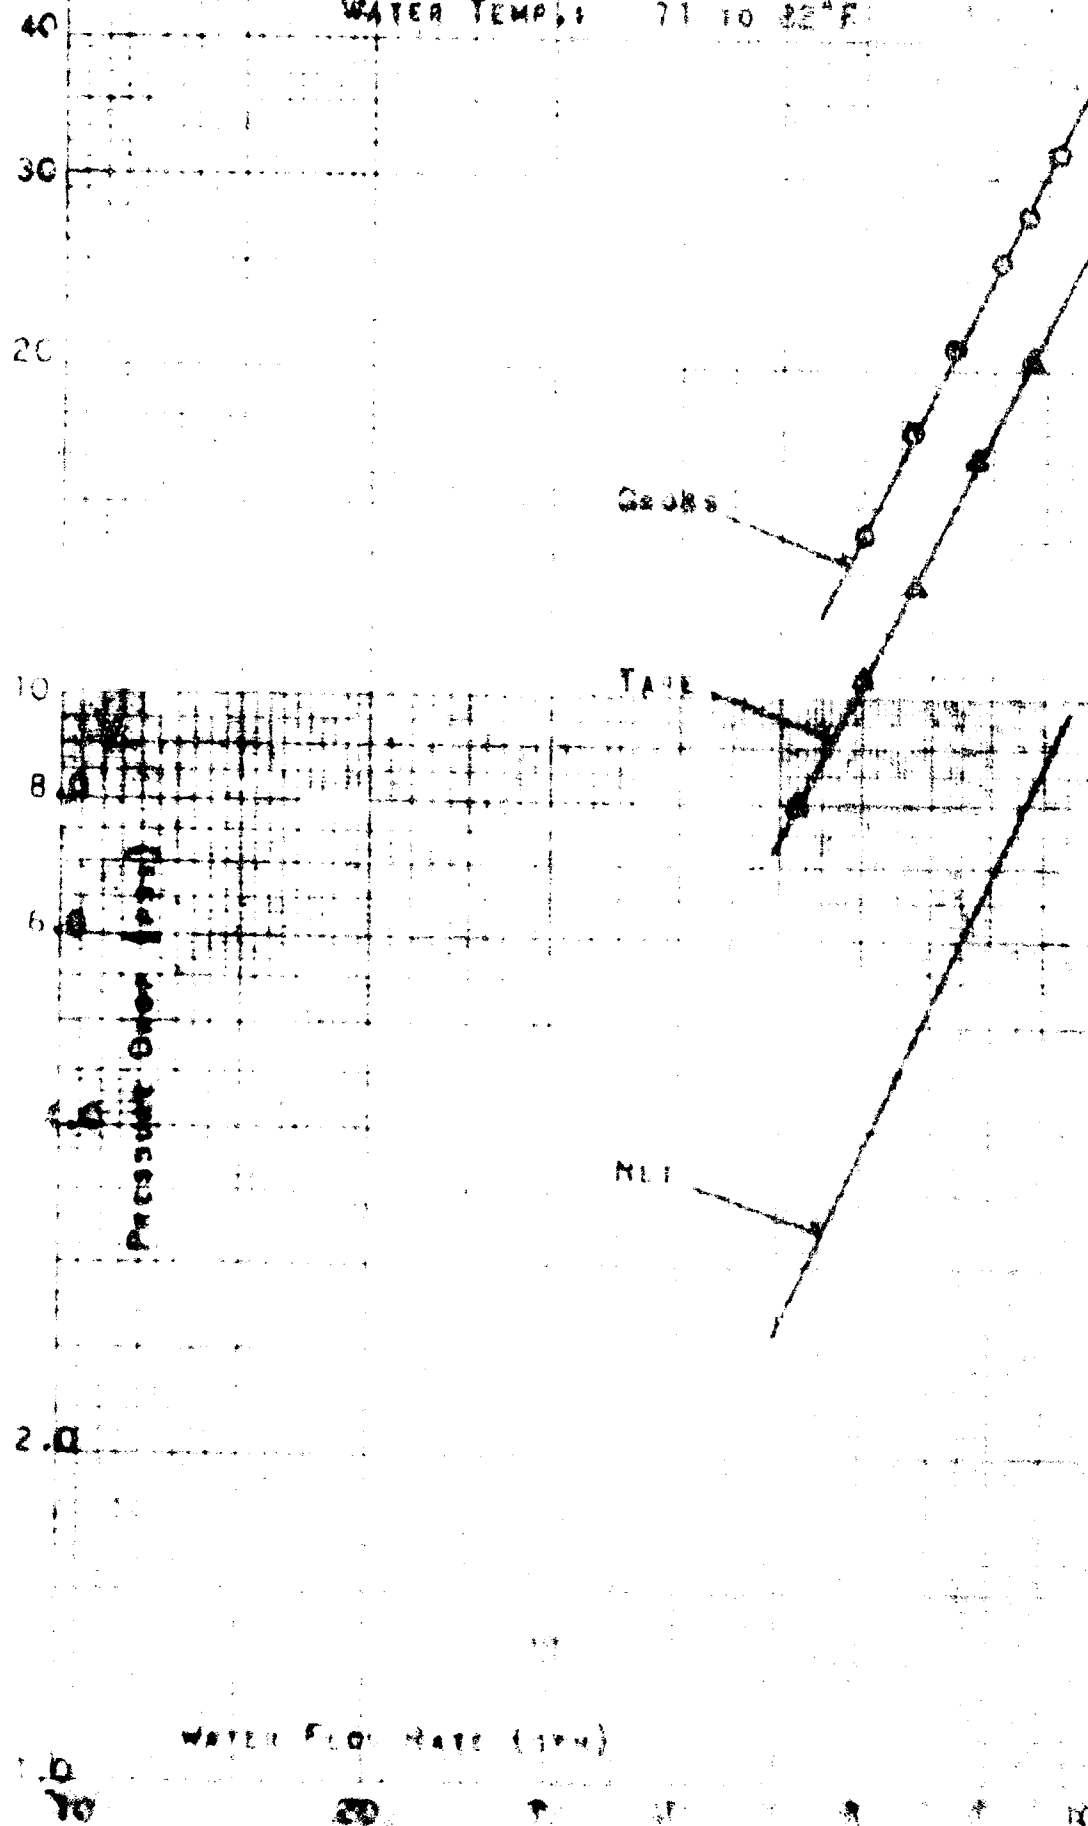
# FLOW CAPACITY TEST

AT A WATER FLOW RATE OF 70 GPM, THE PRESSURE DROP WAS DETERMINED TO BE 5.2 PSID.

TEST MEDIUM - WATER  
 INLET PRESS: 15 TO 32 P.S.I.  
 WATER TEMP: 71 TO 82°F

THE TEST RESULTS ARE GRAPHICALLY PRESENTED IN FIGURE 1.

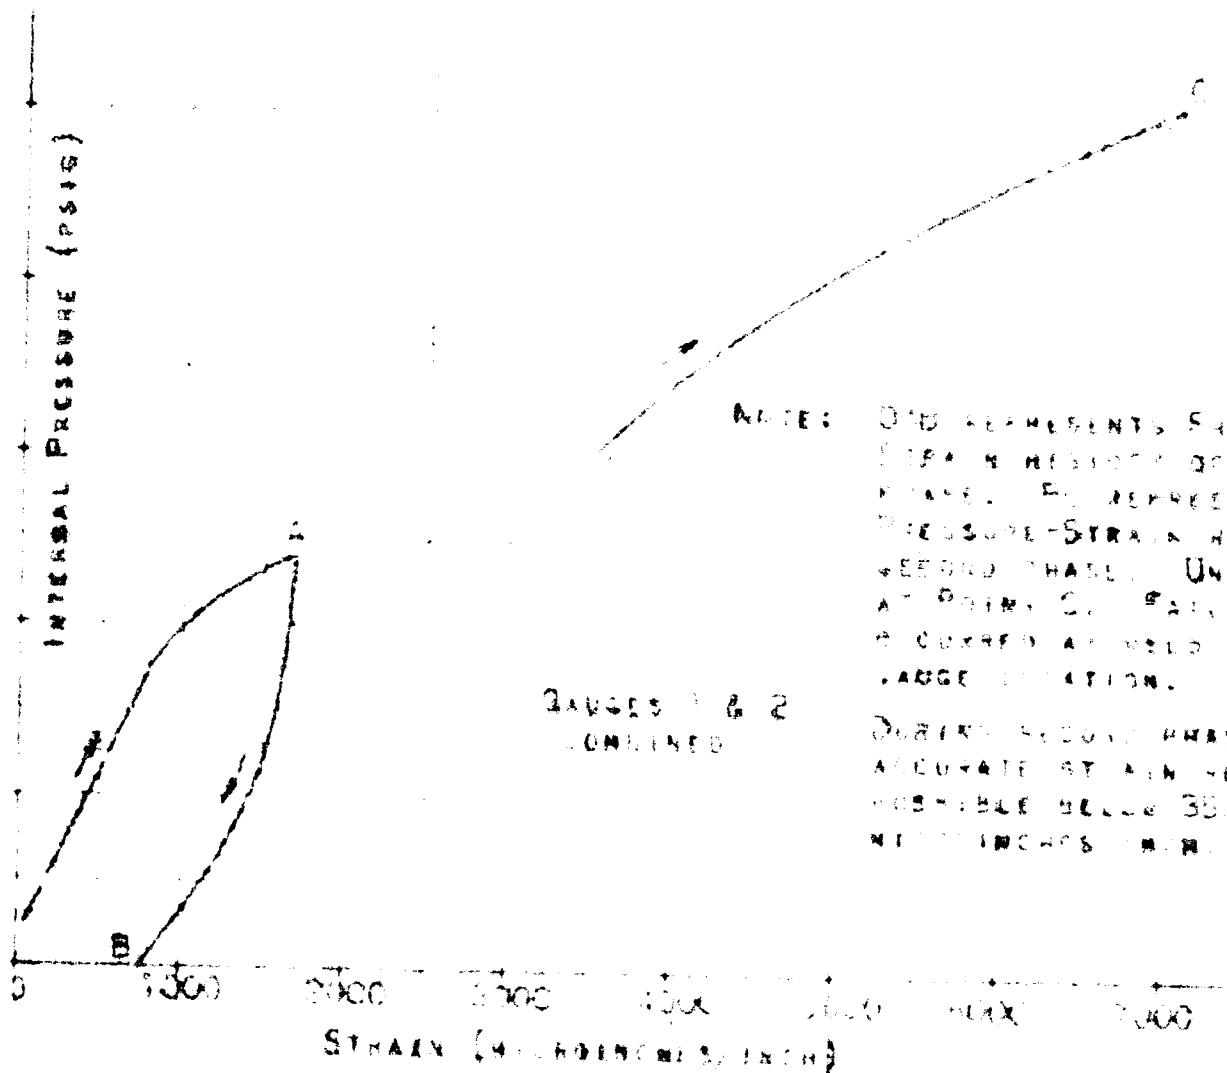
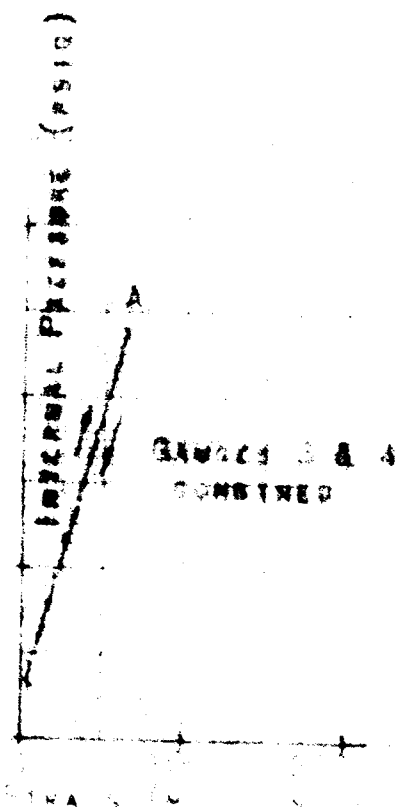
# FIGURE NUMBER 2

## BURST PRESSURE TEST (UNIT 1)

POST YIELD TYPE STRAIN GAUGES WERE ATTACHED TO THE VALVE BODY OUTER SURFACE AS SHOWN IN FIGURE 1 OF APPENDIX A. THE INTERNAL PRESSURE VFF US STRAIN RELATION AS EVALUATED FROM RECORDINGS IS SHOWN IN FIGURE 2.

DURING THE FIRST PHASE OF THE BURST PRESSURE TEST, THE INTERNAL PRESSURE WAS INCREASED FROM ZERO TO 2400 PSIG, SHOWN AS POINT A ON FIGURE 2. YIELDING OCCURRED AT THE LOCATIONS OF GAUGES 1 AND 2 (OVER THREADED PORTIONS OF BODY). THE PRESSURE WAS REDUCED TO ZERO PSIG, (POINT B OF FIGURE 1) AND A RESIDUAL STRAIN OF 780 MICROINCHES/INCH WAS RECORDED ON GAUGES 1 AND 2 WHICH IS COMPARABLE TO THE MEASURED INCREASE IN DIAMETER (TABLE 1). NO YIELDING OCCURRED ON GAUGES 3 AND 4.

FOR THE SECOND PHASE OF THE BURST PRESSURE TEST, THE STRAIN GAUGE RECORDING SCALE WAS CHANGED IN ANTICIPATION OF A LARGE STRAIN. THIS ARRANGEMENT DID NOT PERMIT ACCURATE READOUT BELOW 3300 MICROINCHES/INCH.
